SERVICE BULLETIN

THROTTLE CABLE Z BEND PULLED OUT

NO. 2SD

RE: All surface drive engines

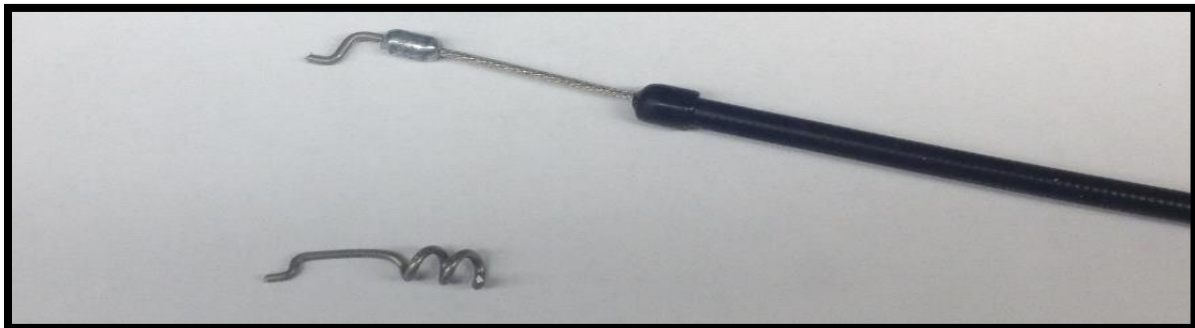
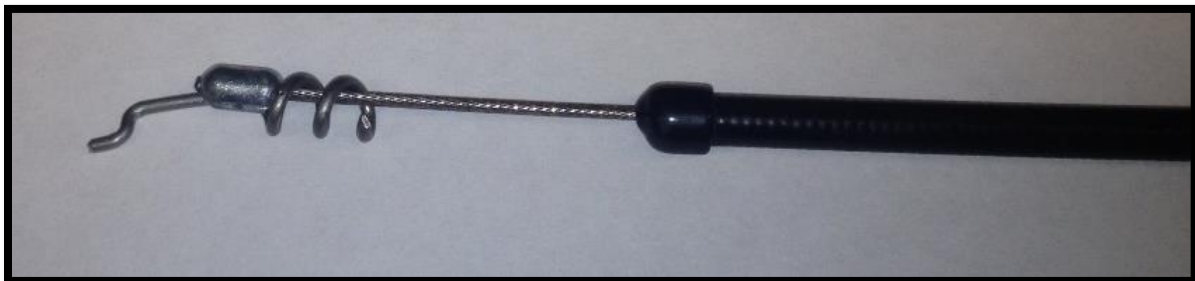
PROBLEM: Z bend pulled out of ball on end of cable.

CONDITION FOUND: Cable was frozen and Z bend pulled out.

SOLUTION: Add Z bend made from inner wire to end of cable which can be purchased at Go-Devil.

Note: After Z bend is installed it will be necessary to readjust the outer cable clamp on the throttle cable.
